Archaeological Documentation and Reconstruction of the 17A Derelict Vessel, Back River, Georgia

Abstract

Due to the widening of the Highway 17 Bridge over Back River, Georgia, the excavation of a late-nineteenth-century bark (barque) was carried out by personnel from Tidewater Atlantic Research (TAR) of Washington, North Carolina. Because of the amount of hull structure only accessible by diving and the limited amount of time the remaining elements of the wreck were exposed at low tide, traditional approaches to mapping and documentation would not produce sufficient data in the time allotted for the field investigation. The decision was made to employ the Vulcan Spatial Measurement System for mapping. This system would provide highly accurate, 3-dimensional points for use in modeling the shipwreck digitally. Data collected using the Vulcan system was imported into Rhinoceros, a 3-dimensional Computer-Aided Design (CAD) program. Using approximately 3,000 points in conjunction with photographs and measured drawings, TAR personnel were able to accurately record and reconstruct the surviving remains of the vessel.

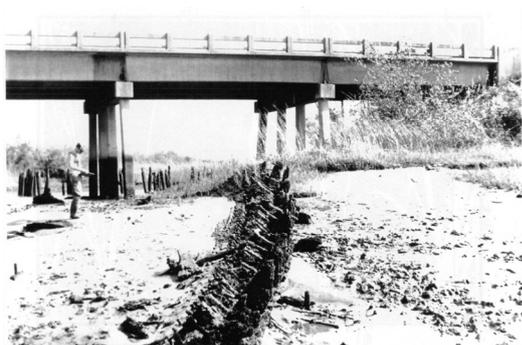
Figure 1. Recording exposed remains of the GA BR 17 derelict in 1991.

During the 1991 TAR survey, GA BR 17 was identified as a heavily constructed sailing vessel that measured 121 feet in length and 26 feet 8 inches in width (see fig. 1). The construction features suggested that the vessel

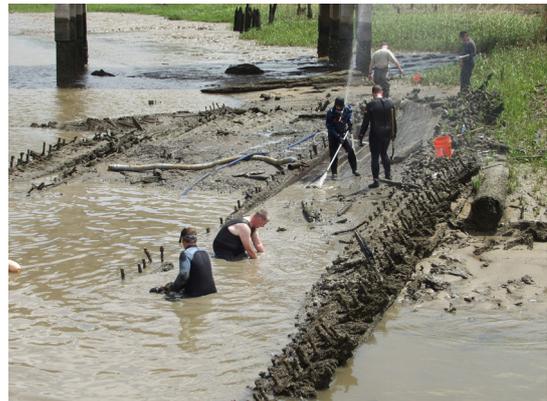
Figure 2. *Clearing debris and sediment from the starboard side of the hull.*

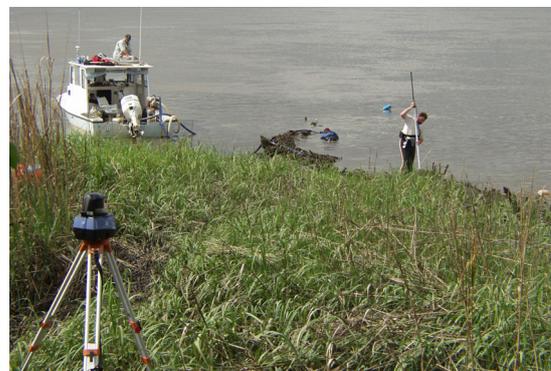
Figure 3. *One of two laser transmitters mounted on tripods in the marsh.*

The two laser transmitters were mounted on tripods in the marsh south of the wreck (see fig. 3). The system was calibrated using a combination of the datums and permanent references on the hull, such as well-secured bolts, spikes, and pins. Once calibrated, the laser was used to record a sufficient number of data points to define the three-dimensional characteristics of each feature. Working for a total of four days in between tides, the laser system was capable of recording thousands of three-dimensional data points. In the same amount of time, traditional methods would produce less than 10% of that number. As the tide ebbed, mapping proceeded aft and as it rose, mapping activity returned toward the bow.

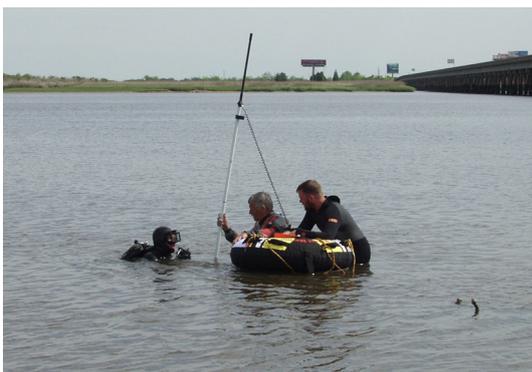
Figure 4. Mapping the stern.

Once the stern structure was understood and diagnostic features were identified, the laser system was employed for mapping. With the transmitters mounted on tripods in the marsh and the system calibrated to reference points on the wreck, mapping underwater sections of the hull commenced. This required extensions to the wand and floating the data recorder in a waterproof vessel. A diver positioned the tip of the wand on the edges of timbers to be recorded. The command to record was transmitted to an individual holding the wand and the data was recorded by a third person operating the data recorder (see fig. 4). Using that system, the stern could be recorded in three dimensions without semi-permanent mapping references. Mapping of selected features on the port side of the hull was accomplished to provide insight into the configuration of wales, clamps, and hanging knees.
